**Flood Control Project Maintenance
Levee Inspections**
LMA District Cover Sheet
Spring 2018 Levee Inspection Results

Reclamation District No. 0999 Netherlands

Spring 2018 Levee Inspection Results

Waterway			Bank	Unit Miles
Unit No. 01 Yolo Bypass			Left	15.41
	Spring (March - May)	Summer (June - August)	(September - November) Fall	Winter (December - February)
Unit Maintenance Rating (Fall Only)				
Date of Inspection	5/8/2018 - 5/8/2018			
DWR Inspector	Dave Torres			
Accompanied By	Tom Slater RD999

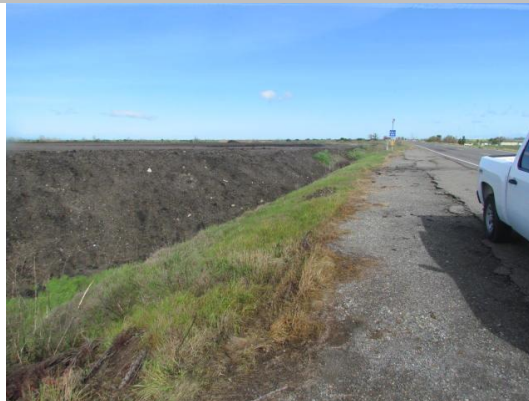
Photo 1 of 5 : SP_2018_RD0999_232_1_20180301_00001.jpg

LM Start	0.12	Rating **	U	Issue No.	1 (cont)
LM End	0.39	Issue Type +	En	Location *	WS

Looking west at filled on waterward berm (spring 2016)

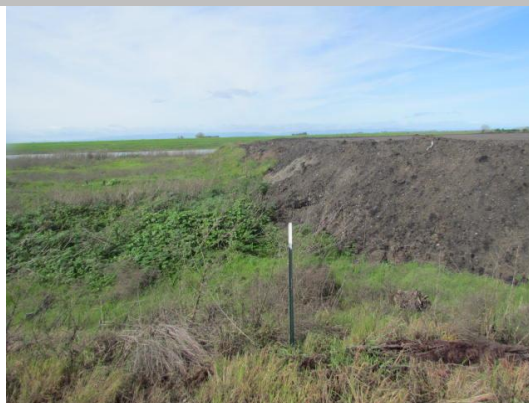
Photo 2 of 5 : SP_2018_RD0999_232_1_20180301_00002.jpg

Looking west at filled on waterward berm. (spring 2016)

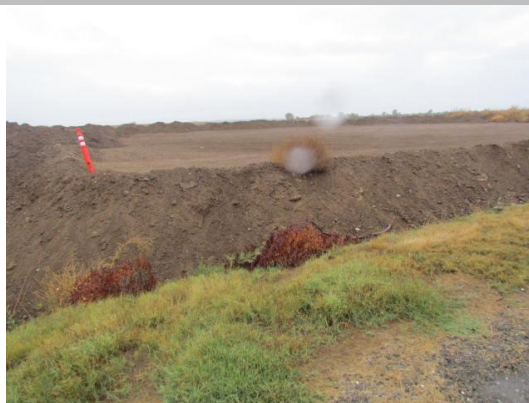
Photo 4 of 5 : SP_2018_RD0999_232_1_20180301_00004.jpg

LM Start	0.12	Rating **	U	Issue No.	1 (cont)	
LM End	0.39	Issue Type +	En	Location *	WS	
Category	Earthen Levee			GPS Latitude/Longitude		
				Start	End	
Item	Encroachments			38.503346 °	38.499389 °	
				-121.582116 °	-121.581933 °	
DWR ID	DWR_RD0999_01_s_2012_1					
Comment Code						
MA : Material						
Inspector Comment						
Landfill has been in place for several years. Landowner is hauling additional material on waterward berm.

Looking west at new fill on waterward berm fall 2015.

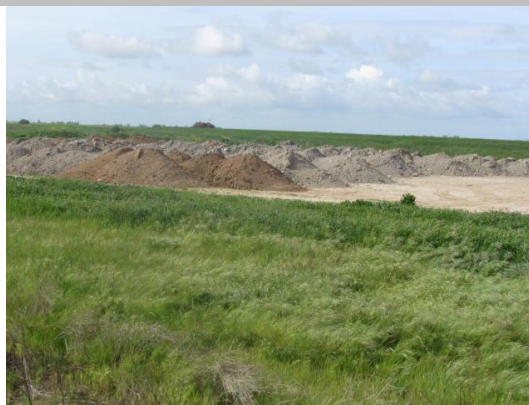
Photo 5 of 5 : SP_2018_RD0999_232_1_20180301_00005.jpg

LM Start	0.12	Rating **	U	Issue No.	1 (cont)
LM End	0.39	Issue Type +	En	Location *	WS

Looking west at new material on waterward berm.

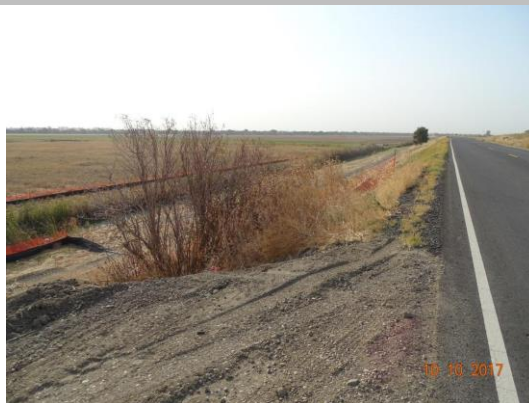
Photo 1 of 1 : SP_2018_RD0999_232_3_20180301_00011.jpg

LM Start	0.27	Rating **	M	Issue No.	3
LM End	0.27	Issue Type +	Ma	Location *	LS
Category	Earthen Levee			GPS Latitude/Longitude	
				Start	End
Item	Vegetation			38.501113 °	38.501113 °
				-121.581975 °	-121.581975 °
DWR ID	DWR_RD0999_01_s_2012_3				
Comment Code					
V4 : Elderberries are blocking visibility and flood fight capability.					
Inspector Comment

View of landside slope looking south.

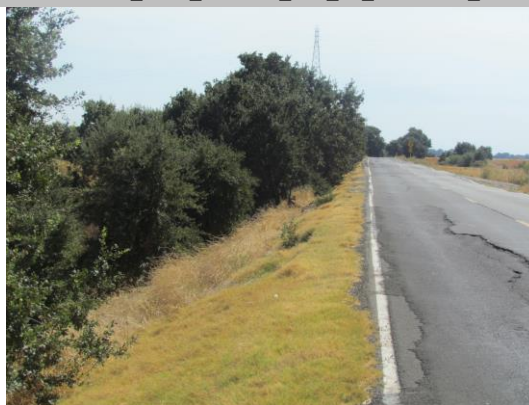
Photo 1 of 2 : SP_2018_RD0999_232_30_20180301_00024.jpg

LM Start	1.79	Rating **	M	Issue No.	30
LM End	2.04	Issue Type +	Ma	Location *	LS
Category	Earthen Levee			GPS Latitude/Longitude	
				Start	End
Item	Trim / Thin Trees			38.479165 °	38.475463 °
				-121.580640 °	-121.580722 °
DWR ID	DWR_RD0999_01_s_2012_30				
Comment Code					
T1 : Trim trees to at least five feet above ground level.					
Inspector Comment

Looking southeast at dense trees on landward slope. (Fall 2016)

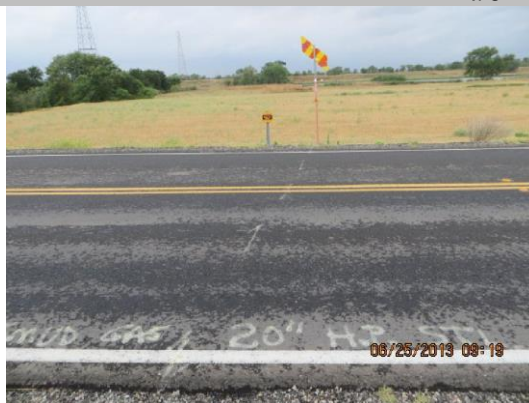
Photo 1 of 2 : UCIP_SP_2018_16324_27501.jpg

LM Start	2.09	Rating **	M	Issue No.	920
LM End	2.09	Issue Type +	En	Location *	
Category	Supplemental			GPS Latitude/Longitude	
				Start	End
Item	DWR UCIP Field Study			38.474783 °	38.474783 °
				-121.580428 °	-121.580428 °
DWR ID					
Comment Code					
Inspector Comment					
FS_ID:16324 DS_ID:23957 EP_NO: N/A Repair Type: Non-Urgent Crossing Status: Found UCIP Comments: Need to determine permit for this crossing. FIELD_STRUCT_DESC: 20-inch steel gas line through the levee at an unknown depth. Gasline markers on both shoulders. (Permit No. 16311, 1996) FS Date: 6/25/2013

Gasline markers on WS shoulder with USAA paint on roadway.

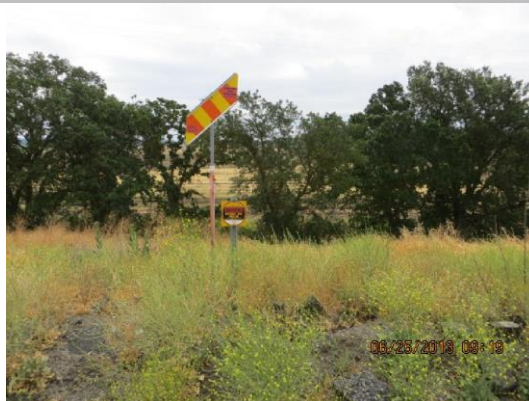
Photo 2 of 2 : UCIP_SP_2018_16324_27500.jpg

LM Start	2.09	Rating **	M	Issue No.	920 (cont)	
LM End	2.09	Issue Type +	En	Location *		
Category	Supplemental			GPS Latitude/Longitude		
				Start		End
Item	DWR UCIP Field Study			38.474783 °		38.474783 °
				-121.580428 °		-121.580428 °
DWR ID						
Comment Code						
Inspector Comment						
FS_ID:16324 DS_ID:23957 EP_NO: N/A Repair Type: Non-Urgent Crossing Status: Found UCIP Comments: Need to determine permit for this crossing. FIELD_STRUCT_DESC: 20-inch steel gas line through the levee at an unknown depth. Gasline markers on both shoulders. (Permit No. 16311, 1996) FS Date: 6/25/2013

Gasline marker on LS shoulder.

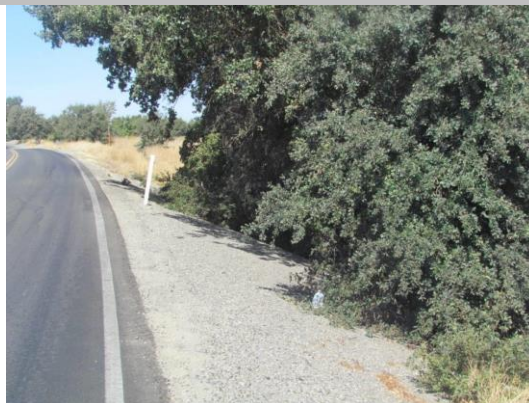
Photo 1 of 2 : SP_2018_RD0999_232_31_20180301_00026.jpg

LM Start	2.13	Rating **	U	Issue No.	31
LM End	2.13	Issue Type +	Ma	Location *	LS
Category	Earthen Levee			GPS Latitude/Longitude	
				Start	End
Item	Trim / Thin Trees			38.474200 °	38.474200 °
				-121.580480 °	-121.580480 °
DWR ID	DWR_RD0999_01_s_2012_31				
Comment Code					
T1 : Trim trees to at least five feet above ground level.					
Inspector Comment

Looking north at untrimmed trees on landward slope. (Fall 2016)

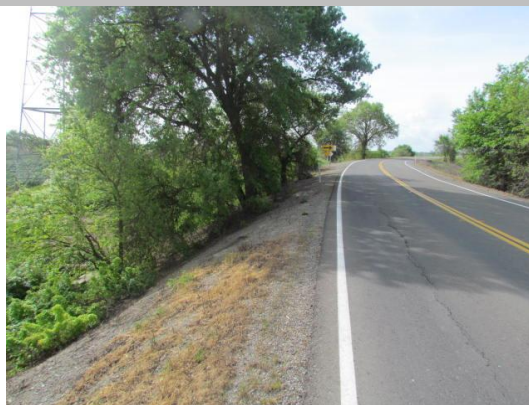
Photo 2 of 2 : SP_2018_RD0999_232_31_20180301_00027.jpg

LM Start	2.13	Rating **	U	Issue No.	31 (cont)
LM End	2.13	Issue Type +	Ma	Location *	LS

Looking southeast at untrimmed trees on landward slope. (Spring 2016)

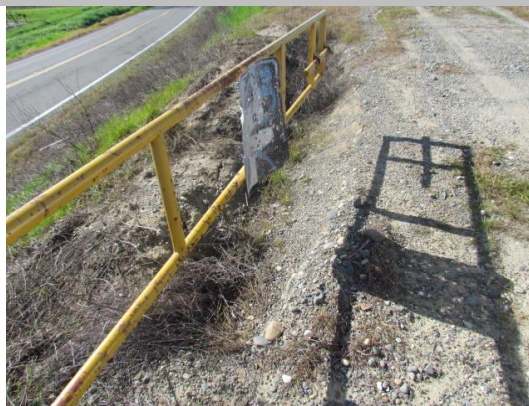
Photo 1 of 4 : SP_2018_RD0999_232_40_20180301_00033.jpg

LM Start	2.51	Rating **	M	Issue No.	40
LM End	2.51	Issue Type +	Ma	Location *	LS
Category	Earthen Levee			GPS Latitude/Longitude	
				Start	End
Item	Encroachments			38.469048 °	38.469048 °
				-121.583075 °	-121.583075 °
DWR ID	DWR_RD0999_01_s_2012_40				
Comment Code					
MA : Material					
Inspector Comment					
Excavation activity on landside shoulder. Hole is approximately 15ft x 12" x 15". Hole appears to be excavated by a backhoe.

Looking south at trench along landward shoulder. (spring 2016)

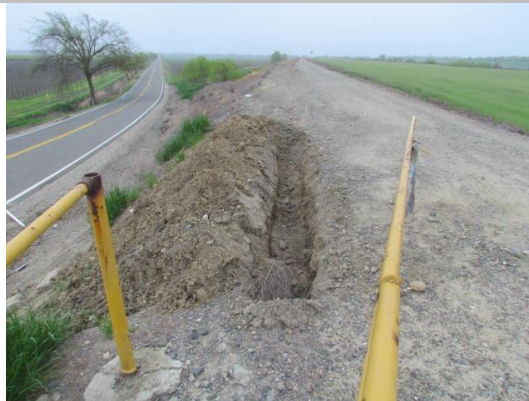
Photo 2 of 4 : SP_2018_RD0999_232_40_20180301_00034.jpg

LM Start	2.51	Rating **	M	Issue No.	40 (cont)
LM End	2.51	Issue Type +	Ma	Location *	LS

Looking south at excavation on landside shoulder.

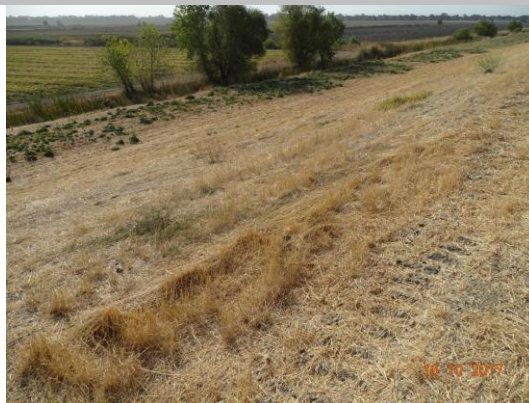
Photo 1 of 3 : SP_2018_RD0999_232_51_20180301_00052.jpg

LM Start	3.22	Rating **	M	Issue No.	51
LM End	3.22	Issue Type +	Ma	Location *	LS
Category	Earthen Levee			GPS Latitude/Longitude	
				Start	End
Item	Slope Stability			38.459399 °	38.459399 °
				-121.587523 °	-121.587523 °
DWR ID	DWR_RD0999_01_s_2013_51				
Comment Code					
S1 : Repair slope instability.					
Inspector Comment					
Depression on landward shoulder and slope 40' x 20'. Earthen material appears to be sliding toward levee toe.

View of landside slope looking south.

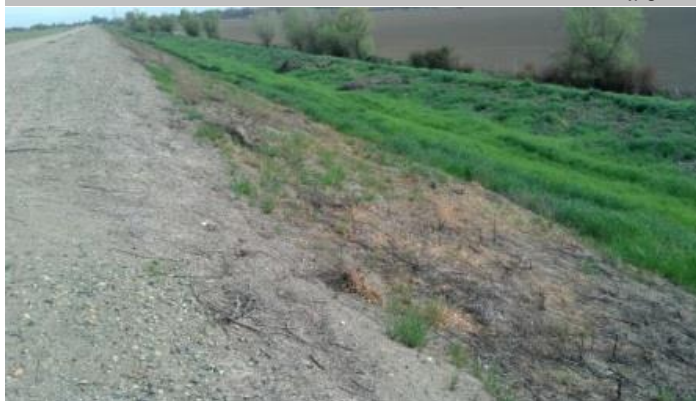
Photo 3 of 3 : SP_2018_RD0999_232_51_20180301_00054.jpg

LM Start	3.22	Rating **	M	Issue No.	51 (cont)	
LM End	3.22	Issue Type +	Ma	Location *	LS	
Category	Earthen Levee			GPS Latitude/Longitude		
				Start		End
Item	Slope Stability			38.459399 °		38.459399 °
				-121.587523 °		-121.587523 °
DWR ID	DWR_RD0999_01_s_2013_51					
Comment Code						
S1 : Repair slope instability.						
Inspector Comment						
Depression on landward shoulder and slope 40' x 20'. Earthen material appears to be sliding toward levee toe.

Looking north at depression on landside shoulder and slope. (Spring 2016)

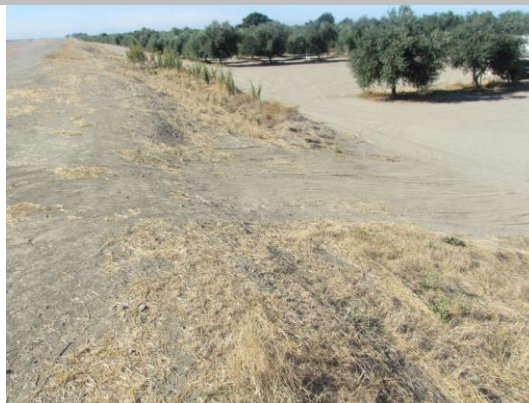
Photo 1 of 2 : SP_2018_RD0999_232_27_20180301_00020.jpg

LM Start	4.31	Rating **	M	Issue No.	27
LM End	4.31	Issue Type +	Ma	Location *	WS
Category	Earthen Levee			GPS Latitude/Longitude	
				Start	End
Item	Slope Stability			38.444560 °	38.444560 °
				-121.594440 °	-121.594440 °
DWR ID	DWR_RD0999_01_f_2012_27				
Comment Code					
S3 : Repair the levee slope damaged by vehicle traffic and prevent access where possible.					
Inspector Comment					
Local farmer causing slope damage by driving equipment and trucks on slope.

Looking at slope damage cause by vehicle traffice on waterward slope.
(Fall 2016)

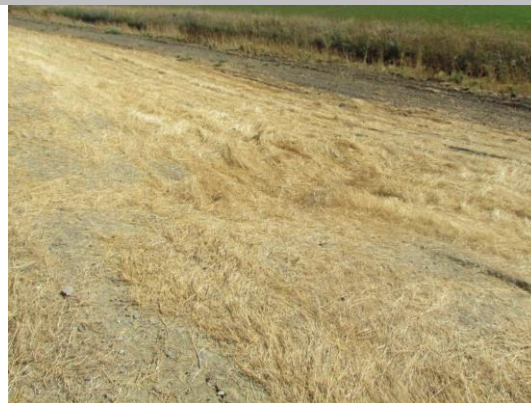
Photo 1 of 2 : SP_2018_RD0999_232_58_20180301_00057.jpg

LM Start	7.61	Rating **	M	Issue No.	58
LM End	7.61	Issue Type +	Ma	Location *	LS
Category	Earthen Levee			GPS Latitude/Longitude	
				Start	End
Item	Erosion / Bank Caving			38.399600 °	38.399600 °
				-121.615224 °	-121.615224 °
DWR ID	DWR_RD0999_01_f_2016_58				
Comment Code					
Inspector Comment					
Depression 10' by 20' on landward slope.

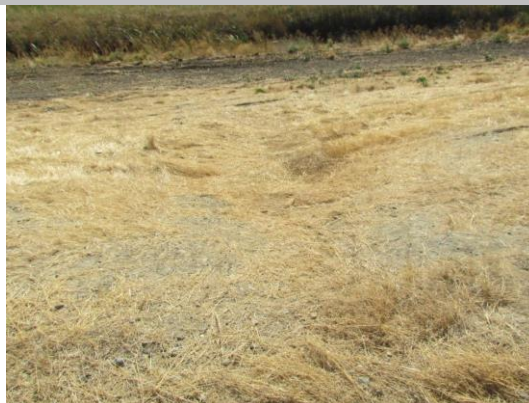
Photo 2 of 2 : SP_2018_RD0999_232_58_20180301_00058.jpg

LM Start	7.61	Rating **	M	Issue No.	58 (cont)	
LM End	7.61	Issue Type +	Ma	Location *	LS	
Category	Earthen Levee			GPS Latitude/Longitude		
				Start		End
Item	Erosion / Bank Caving			38.399600 °	38.399600 °	
				-121.615224 °	-121.615224 °	
DWR ID	DWR_RD0999_01_f_2016_58					
Comment Code						
Inspector Comment						
Depression 10' by 20' on landward slope.

Looking northeast at depression on landward slope.

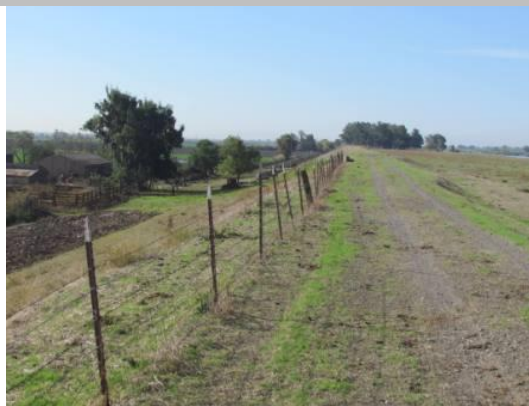
Photo 1 of 2 : SP_2018_RD0999_232_918_20180301_00065.jpg

LM Start	9.12	Rating **	M	Issue No.	918
LM End	9.25	Issue Type +	En	Location *	LS
Category	Earthen Levee			GPS Latitude/Longitude	
				Start	End
Item	Encroachments			38.379019 °	38.377261 °
				-121.624777 °	-121.625619 °
DWR ID	DWR_RD0999_01_s_2012_918				
Comment Code					
FE : Fence					
Inspector Comment					
Fence along landward shoulder.

Looking south at fence along landside shoulder.

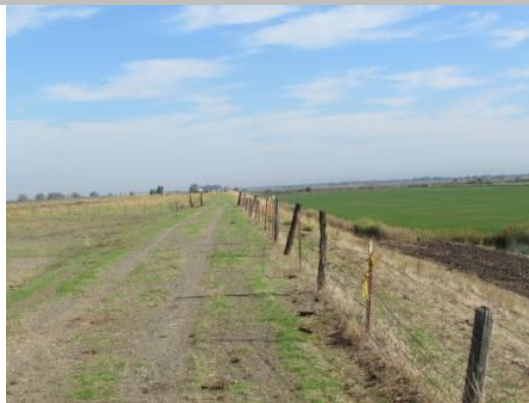
Photo 2 of 2 : SP_2018_RD0999_232_918_20180301_00066.jpg

Looking north at fence along landside shoulder.

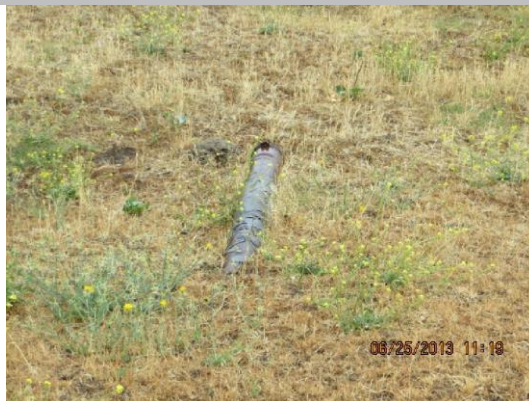
Photo 2 of 3 : UCIP_SP_2018_24413_43356.jpg

LM Start	9.50	Rating **	M	Issue No.	921
LM End	9.50	Issue Type +	En	Location *	
Category	Supplemental			GPS Latitude/Longitude	
				Start	End
Item	DWR UCIP Field Study			38.373823 °	38.373823 °
				-121.627212 °	-121.627212 °
DWR ID					
Comment Code					
Inspector Comment					
FS_ID:24413					
DS_ID:22750					
EP_NO: 13300					
Repair Type: Non-Urgent					
Crossing Status: Found					
UCIP Comments: Pipe abandoned and should be done so properly.					
FIELD_STRUCT_DESC: 6-inch coated steel irrigation pipe through the levee, 3 feet below the crown. Joint pole (JP) and meter at abandoned pump location on the landside (LS) toe. (Permit No. 13300, 1981 - Eldon M. Studarus). [Additional Reference(s): DWR Levee Log, 1992].					
FS Date: 6/25/2013

Pipe open on WS slope.

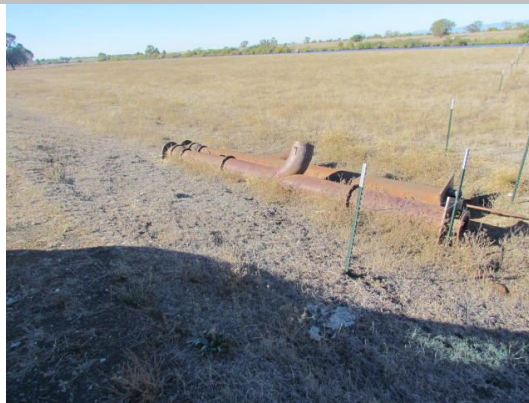
Photo 1 of 1 : SP_2018_RD0999_232_47_20180301_00043.jpg

LM Start	9.51	Rating **	M	Issue No.	47
LM End	9.51	Issue Type +	En	Location *	WS
Category	Earthen Levee			GPS Latitude/Longitude	
				Start	End
Item	Encroachments			38.373740 °	38.373740 °
				-121.627257 °	-121.627257 °
DWR ID	DWR_RD0999_01_f_2015_47				
Comment Code					
PI : Pipe					
Inspector Comment					
Abandoned pipes at waterside toe.

Looking southwest at abandoned irrigation pipes at waterward toe.

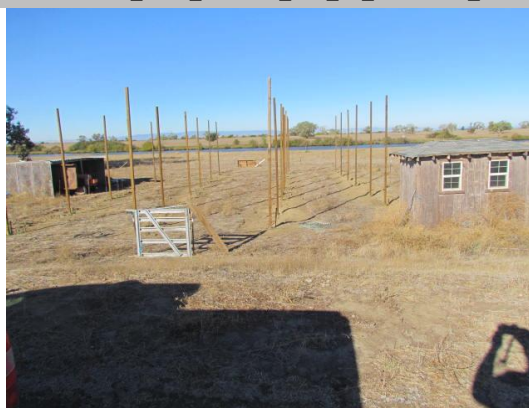
Photo 1 of 1 : SP_2018_RD0999_232_56_20180301_00055.jpg

LM Start	9.64	Rating **	M	Issue No.	56
LM End	9.64	Issue Type +	En	Location *	WS
Category	Earthen Levee			GPS Latitude/Longitude	
				Start	End
Item	Encroachments			38.372002 °	38.372002 °
				-121.628052 °	-121.628052 °
DWR ID	DWR_RD0999_01_f_2015_56				
Comment Code					
CR : Crops					
Inspector Comment					
Landowner planted crops and installed poles and tool sheds on waterside berm without permit

Looking at west at crop, poles and tool sheds on waterward berm.

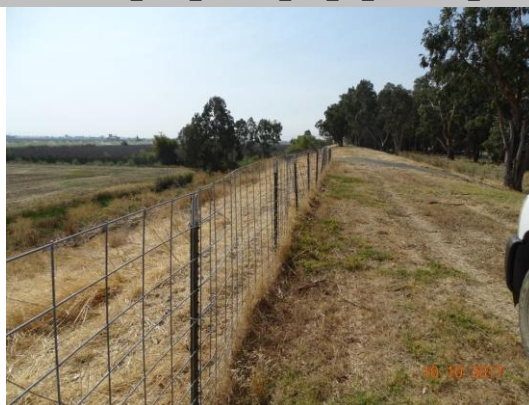
Photo 1 of 1 : SP_2018_RD0999_232_34_20180301_00028.jpg

LM Start	9.65	Rating **	M	Issue No.	34
LM End	9.66	Issue Type +	En	Location *	LS
Category	Earthen Levee			GPS Latitude/Longitude	
				Start	End
Item	Encroachments			38.371885 °	38.371652 °
				-121.628087 °	-121.628198 °
DWR ID	DWR_RD0999_01_f_2017_34				
Comment Code					
FE : Fence					
Inspector Comment

View of landside slope looking south.

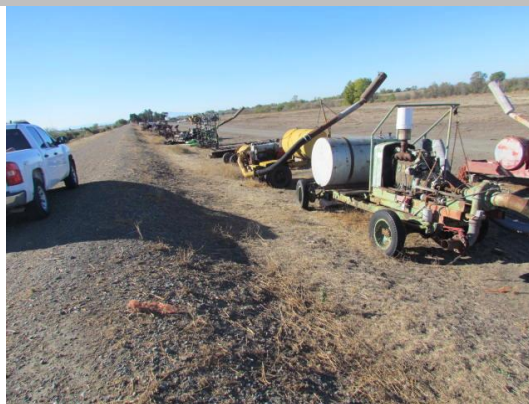
Photo 1 of 1 : SP_2018_RD0999_232_57_20180301_00056.jpg

LM Start	10.33	Rating **	M	Issue No.	57
LM End	10.65	Issue Type +	En	Location *	WS
Category	Earthen Levee			GPS Latitude/Longitude	
				Start	End
Item	Encroachments			38.362528 °	38.358175 °
				-121.632517 °	-121.634490 °
DWR ID	DWR_RD0999_01_f_2015_57				
Comment Code					
EQ : Equipment					
Inspector Comment					
Farm equipment stored at waterward toe.

Looking southwest at farm equipment stored at waterward berm.

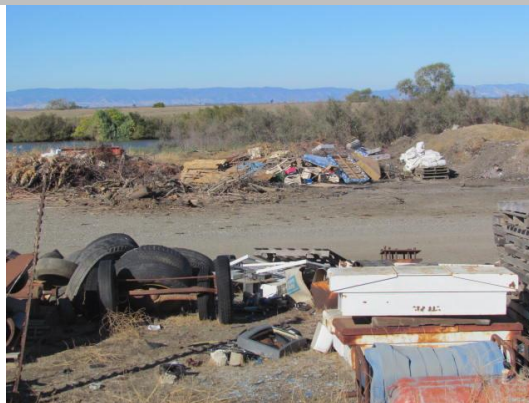
Photo 1 of 2 : SP_2018_RD0999_232_28_20180301_00022.jpg

LM Start	10.57	Rating **	A/W	Issue No.	28
LM End	10.57	Issue Type +	En	Location *	WS
Category	Earthen Levee			GPS Latitude/Longitude	
				Start	End
Item	Encroachments			38.359305 °	38.359305 °
				-121.633949 °	-121.633949 °
DWR ID	DWR_RD0999_01_s_2012_28				
Comment Code					
GA : Garbage					
Inspector Comment					
Large garbage and pruning piles on waterward berm.

Looking west at garbage pile on waterward berm fall 2015.

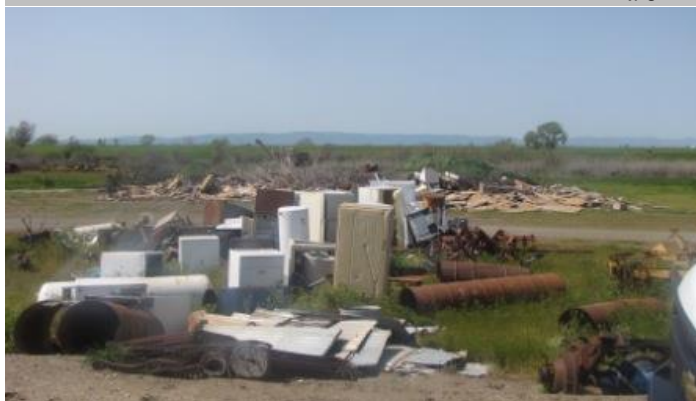
Photo 2 of 2 : SP_2018_RD0999_232_28_20180301_00023.jpg

Looking southwest at garbage on waterside toe and berm.

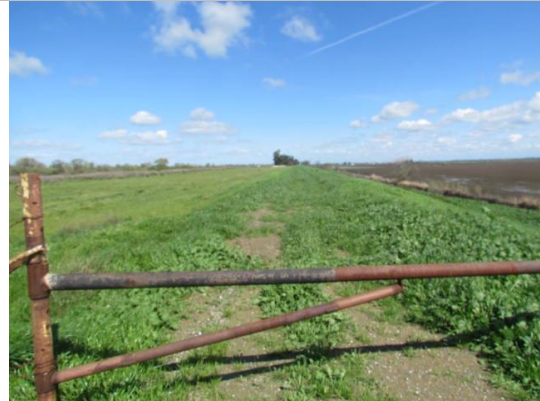
Photo 1 of 1 : SP_2018_RD0999_232_43_20180301_00040.jpg

LM Start	11.30	Rating **	M	Issue No.	43
LM End	11.59	Issue Type +	Ma	Location *	CR
Category	Earthen Levee			GPS Latitude/Longitude	
				Start	End
Item	Crown Surface / Depressions / Rutting			38.349380 °	38.345353 °
				-121.638540 °	-121.640432 °
DWR ID	DWR_RD0999_01_s_2012_43				
Comment Code					
C3 : Add appropriate gravel or road base. Grade and compact.					
Inspector Comment

Looking north at growth on levee crown.

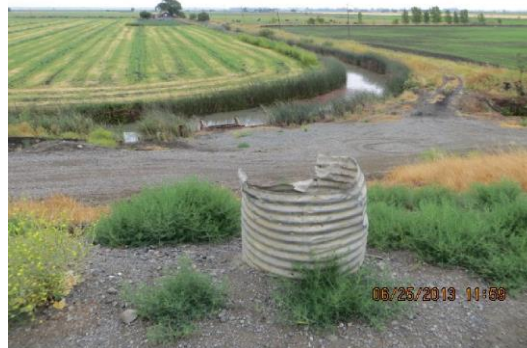
Photo 2 of 3 : UCIP_SP_2018_50097_25414.jpg

FS_ID:50097
DS_ID:22752
EP_NO: 11735
Repair Type: Urgent
Crossing Status: Found
UCIP Comments: 07/07/2016 - Appears abandoned. Pipe is visible in exposed cut on the WS slope of the levee. Riser on LS shoulder damaged from vandalism. welded plate on WS. No pump found on the platform in the drainage ditch. (T. Hatch/UCIP)06/25/2013 - Appears abandoned. Pipe exposed in cut on on WS slope and open at LS toe. No pump or appurtenances. (W. Wylie/UCIP)
FIELD_STRUCT_DESC: *ABANDONED* 24-inch steel drainage pipe through the levee, 7 feet below the crown. Pump in a drainage ditch on the landside (LS) with a sheet pile headwall, not found. Flap gate on the waterside (WS), not found. Siphon breaker in a riser on the LS slope. (Replaced an existing 24-inch steel pipe under Permit No. 11735, 1978 - Reclamation District No. 999). [Additional Reference(s): DWR Levee Log, 1992. USACE Sacramento O&M Manual 113 (Revised), October 1966, (HLM 12.29)].

Siphon breaker in CMP riser on LS shoulder.

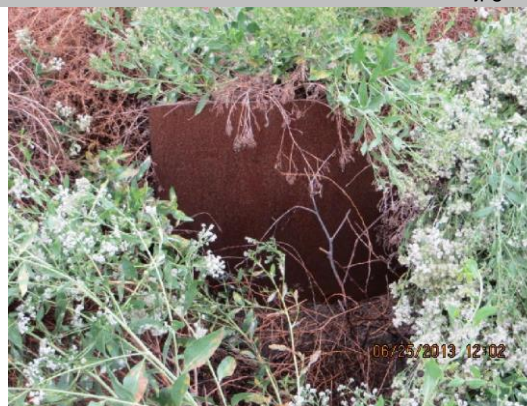
Photo 3 of 3 : UCIP_SP_2018_50097_25418.jpg

Steel plate welded over pipe on WS end at WS slope.

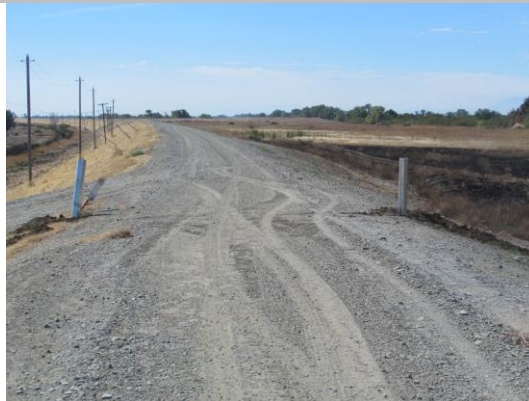
Photo 1 of 3 : SP_2018_RD0999_232_71_20180301_00062.jpg

LM Start	12.28	Rating **	U	Issue No.	71
LM End	12.28	Issue Type +	En	Location *	CR
Category	Earthen Levee			GPS Latitude/Longitude	
				Start	End
Item	Encroachments			38.335814 °	38.335814 °
				-121.643997 °	-121.643997 °
DWR ID	DWR_RD0999_01_f_2016_71				
Comment Code					
FE : Fence					
Inspector Comment					
Landowner is in the process of installing gate acrosss levee crown and on at bottom of ramps on landward.

Looking south at gate poles on landward and waterward shoulder.

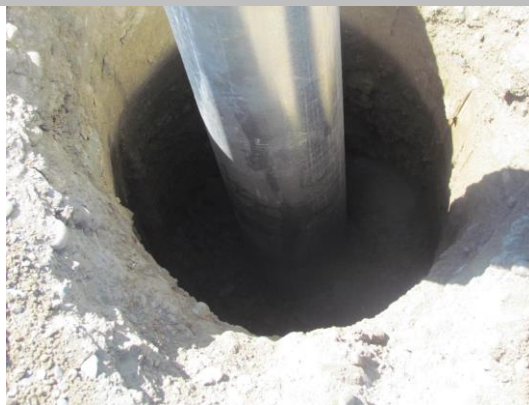
Photo 2 of 3 : SP_2018_RD0999_232_71_20180301_00063.jpg

Looking at typical view of fence and gate poles on levee.

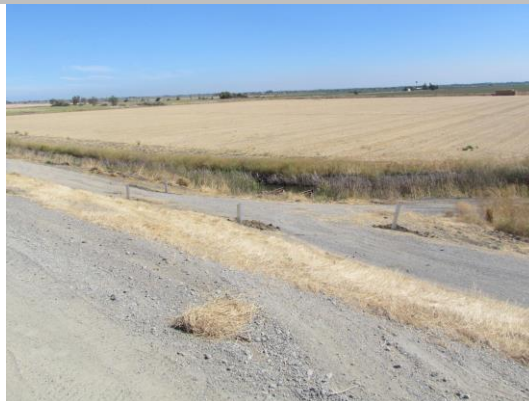
Photo 3 of 3 : SP_2018_RD0999_232_71_20180301_00064.jpg

Looking east at gate and fence poles at landward berm.

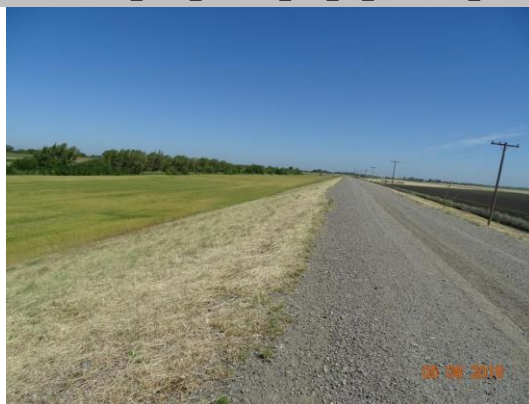
Photo 1 of 1 : SP_2018_RD0999_232_24_20180509_00091.jpg

LM Start	13.64	Rating **	A	Issue No.	24
LM End	13.64	Issue Type +	Ma	Location *	LS
Category	Earthen Levee			GPS Latitude/Longitude	
				Start	End
Item	Vegetation			38.316208 °	38.316208 °
				-121.644951 °	-121.644951 °
DWR ID	DWR_RD0999_01_s_2018_24				
Comment Code					
V1 : Control annual grass and weeds on the levee slopes and easements.					
Inspector Comment					
Good vegetation control.

Good vegetation control waterside looking north.

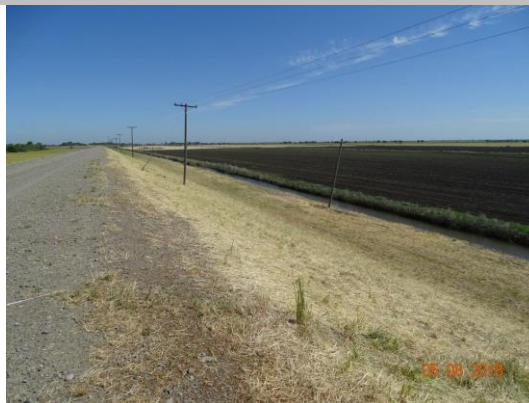
Photo 1 of 1 : SP_2018_RD0999_232_25_20180509_00090.jpg

LM Start	13.64	Rating **	A	Issue No.	25
LM End	13.64	Issue Type +	Ma	Location *	WS
Category	Earthen Levee			GPS Latitude/Longitude	
				Start	End
Item	Vegetation			38.316208 °	38.316208 °
				-121.644951 °	-121.644951 °
DWR ID	DWR_RD0999_01_s_2018_25				
Comment Code					
V1 : Control annual grass and weeds on the levee slopes and easements.					
Inspector Comment					
Good vegetation control.

Good vegetation control landside looking north.

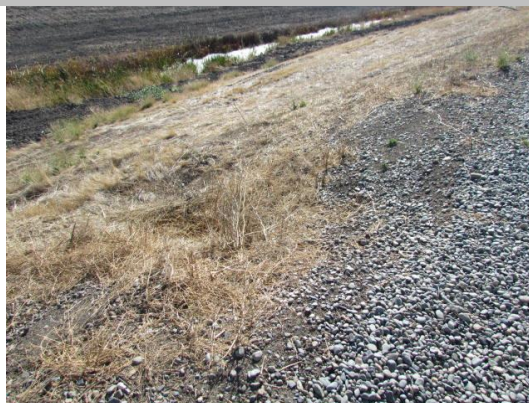
Photo 1 of 4 : SP_2018_RD0999_232_49_20180301_00044.jpg

LM Start	14.04	Rating **	M	Issue No.	49
LM End	14.04	Issue Type +	Ma	Location *	LS
Category	Earthen Levee			GPS Latitude/Longitude	
				Start	End
Item	Erosion / Bank Caving			38.310347 °	38.310347 °
				-121.644955 °	-121.644955 °
DWR ID	DWR_RD0999_01_f_2012_49				
Comment Code					
E1 : Note and monitor erosion site.					
Inspector Comment					
Caving, 4' x 10', on landside slope.

Looking southeast at caving on landward slope fall 2015.

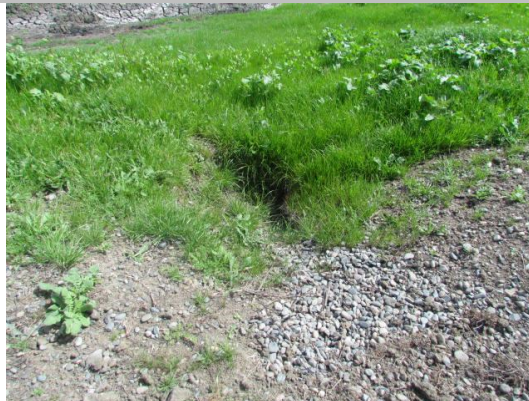
Photo 2 of 4 : SP_2018_RD0999_232_49_20180301_00045.jpg

Looking east at caving on landward shoulder and slope. (Spring 2015)

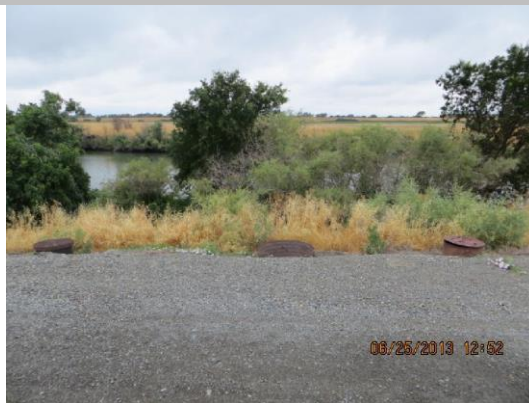
Photo 2 of 3 : UCIP_SP_2018_15366_25230.jpg

LM Start	15.24	Rating **	A/W	Issue No.	925	
LM End	15.24	Issue Type +	Ma	Location *		
Category	Supplemental			GPS Latitude/Longitude		
				Start	End	
Item	DWR UCIP LMA Responsibility			38.293005 °	38.293005 °	
				-121.644974 °	-121.644974 °	
DWR ID						
Comment Code						
Inspector Comment						
FS_ID:15366						
DS_ID:22757						
EP_NO: 14199						
Repair Type: No Action Needed						
Crossing Status: Found						
UCIP Comments:						
FIELD_STRUCT_DESC: 24-inch steel discharge pipe through the						
levee, 6.3 feet below the crown. Pump house on the landside (LS) toe						
with a siphon breaker in a steel riser on the waterside (WS) shoulder.						
(Permit No. 14199, 1985, [owner not indicated in permit database]).						
FS Date: 6/25/2013

siphon breaker in steel riser on WS shoulder

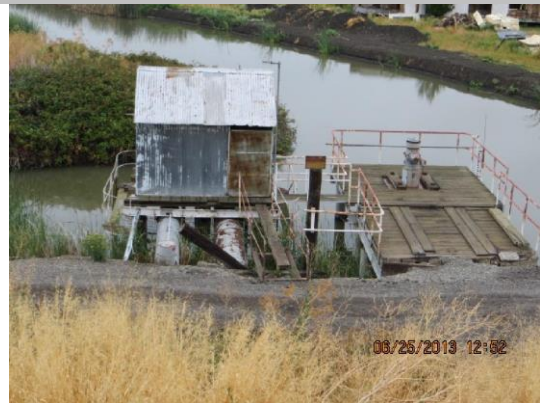
Photo 1 of 3 : UCIP_SP_2018_15365_25227.jpg

LM Start	15.24	Rating **	A/W	Issue No.	926
LM End	15.24	Issue Type +	Ma	Location *	
Category	Supplemental			GPS Latitude/Longitude	
				Start	End
Item	DWR UCIP LMA Responsibility			38.292973 °	38.292973 °
				-121.644977 °	-121.644977 °
DWR ID					
Comment Code					
Inspector Comment					
FS_ID:15365					
DS_ID:22756					
EP_NO: N/A					
Repair Type: No Action Needed					
Crossing Status: Found					
UCIP Comments:					
FIELD_STRUCT_DESC: 30-inch steel drainage pipe through the levee, 7 feet below the crown. Flap gate on the waterside (WS) end. Pump in pump house on the landside (LS) toe. Siphon breaker in a corrugated metal pipe (CMP) riser on the WS shoulder. [Additional Reference(s): DWR Levee Log, 1992. USACE Sacramento O&M Manual 113 (Revised), October 1966, (HLM 15.25) (36-inch pipe listed)].					
FS Date: 6/25/2013

Pumphouse on LS toe.

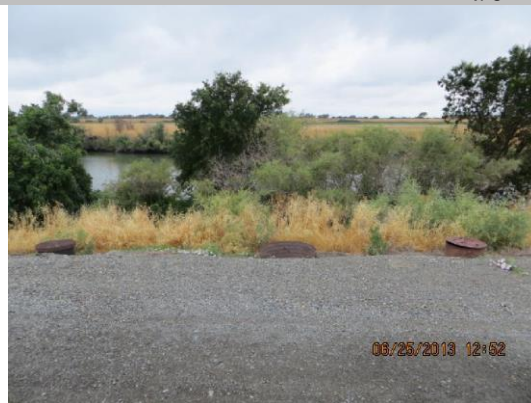
Photo 2 of 3 : UCIP_SP_2018_15365_25226.jpg

LM Start	15.24	Rating **	A/W	Issue No.	926 (cont)	
LM End	15.24	Issue Type +	Ma	Location *		
Category	Supplemental			GPS Latitude/Longitude		
				Start	End	
Item	DWR UCIP LMA Responsibility			38.292973 °	38.292973 °	
				-121.644977 °	-121.644977 °	
DWR ID						
Comment Code						
Inspector Comment						
FS_ID:15365 DS_ID:22756 EP_NO: N/A Repair Type: No Action Needed Crossing Status: Found UCIP Comments: FIELD_STRUCT_DESC: 30-inch steel drainage pipe through the levee, 7 feet below the crown. Flap gate on the waterside (WS) end. Pump in pump house on the landside (LS) toe. Siphon breaker in a corrugated metal pipe (CMP) riser on the WS shoulder. [Additional Reference(s): DWR Levee Log, 1992. USACE Sacramento O&M Manual 113 (Revised), October 1966, (HLM 15.25) (36-inch pipe listed)]. FS Date: 6/25/2013

Siphon breaker in CMP riser on WS shoulder.

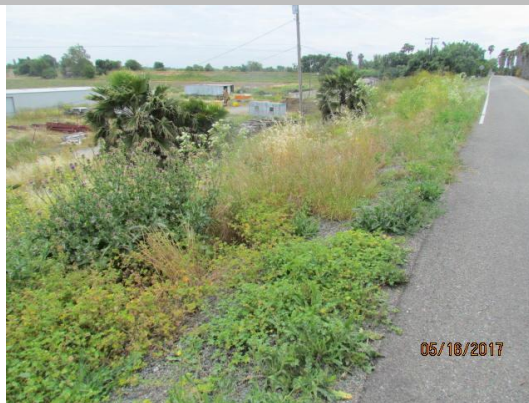
Photo 2 of 2 : SP_2018_RD0999_232_44_20180301_00042.jpg

LM Start	15.26	Rating **	U	Issue No.	44 (cont)	
LM End	15.26	Issue Type +	En	Location *	LS	
Category	Earthen Levee			GPS Latitude/Longitude		
				Start		End
Item	Vegetation			38.292702 °		38.292702 °
				-121.644967 °		-121.644967 °
DWR ID	DWR_RD0999_01_s_2016_44					
Comment Code						
V6 : Landscaping						
Inspector Comment						
Unauthorized palm trees on landward slope and toe.

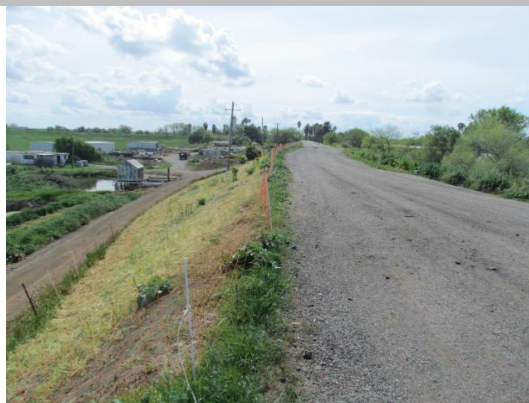
Photo 1 of 3 : SP_2018_RD0999_232_39_20180301_00030.jpg

LM Start	15.27	Rating **	M	Issue No.	39
LM End	15.41	Issue Type +	En	Location *	LS
Category	Earthen Levee			GPS Latitude/Longitude	
				Start	End
Item	Encroachments			38.292578 °	38.290525 °
				-121.644972 °	-121.644902 °
DWR ID	DWR_RD0999_01_s_2012_39				
Comment Code					
FE : Fence					
Inspector Comment					
Landowner has installed fence along landside slope for sheep to maintain levee slope. Landowner should apply for permit for fence. Landowner added additional fencing on landward shoulder and slope.

Looking east at new fencing on landward shoulder and slope. (Spring 2015)

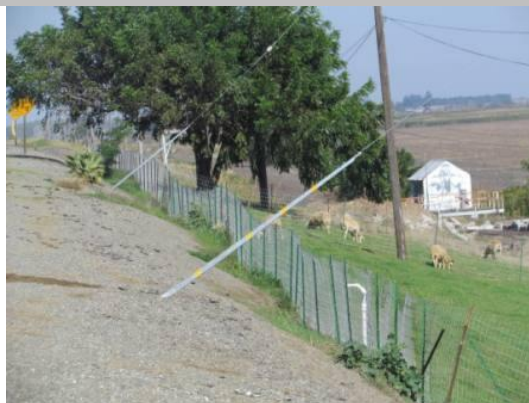
Photo 2 of 3 : SP_2018_RD0999_232_39_20180301_00031.jpg

Looking north at fence along landside slope.

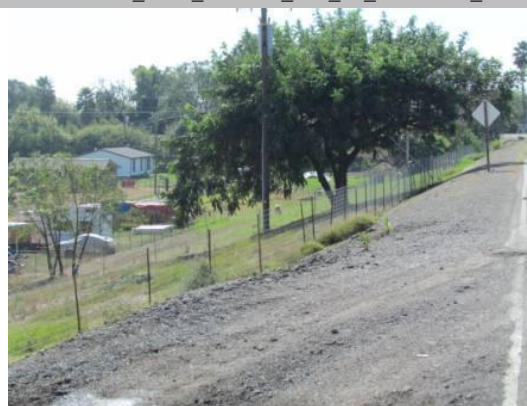
Photo 3 of 3 : SP_2018_RD0999_232_39_20180301_00032.jpg

LM Start	15.27	Rating **	M	Issue No.	39 (cont)
LM End	15.41	Issue Type +	En	Location *	LS
Category	Earthen Levee			GPS Latitude/Longitude	
				Start	End
Item	Encroachments			38.292578 °	38.290525 °
				-121.644972 °	-121.644902 °
DWR ID	DWR_RD0999_01_s_2012_39				
Comment Code					
FE : Fence					
Inspector Comment					
Landowner has installed fence along landside slope for sheep to maintain levee slope. Landowner should apply for permit for fence. Landowner added additional fencing on landward shoulder and slope.

Looking south at fence along landside slope.

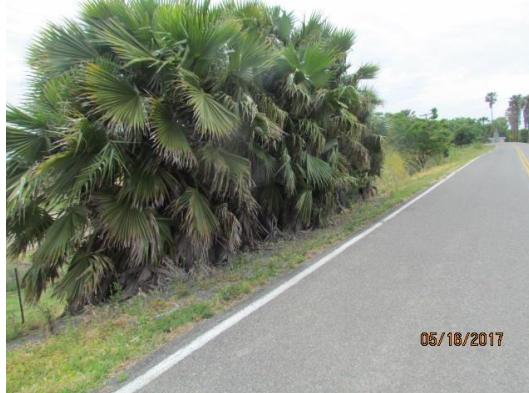
Photo 1 of 4 : SP_2018_RD0999_232_50_20180301_00048.jpg

LM Start	15.33	Rating **	U	Issue No.	50
LM End	15.33	Issue Type +	En	Location *	LS
Category	Earthen Levee			GPS Latitude/Longitude	
				Start	End
Item	Encroachments			38.291663 °	38.291663 °
				-121.644962 °	-121.644962 °
DWR ID	DWR_RD0999_01_f_2012_50				
Comment Code					
TR : Tree or limb					
Inspector Comment					
Planted palm trees on landside shoulder.

Looking east at palm trees (Spring 2017)

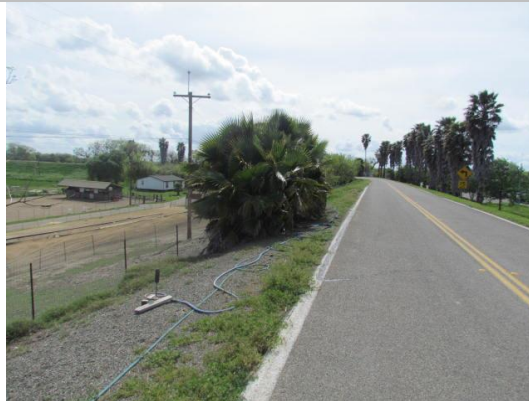
Photo 2 of 4 : SP_2018_RD0999_232_50_20180301_00049.jpg

Looking northeast at a mature palm trees on landward shoulder and slope. (Spring 2015)

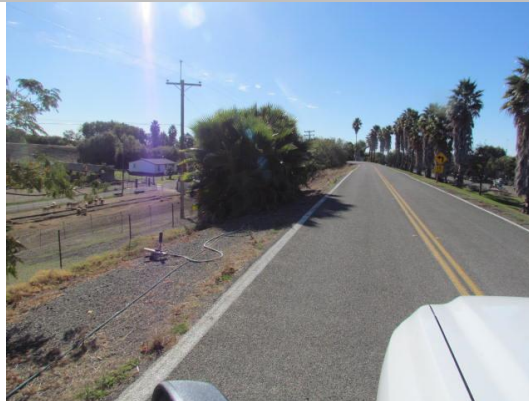
Photo 3 of 4 : SP_2018_RD0999_232_50_20180301_00050.jpg

Looking east at a maturing palm trees on landward shoulder and slope. (Fall 2014)

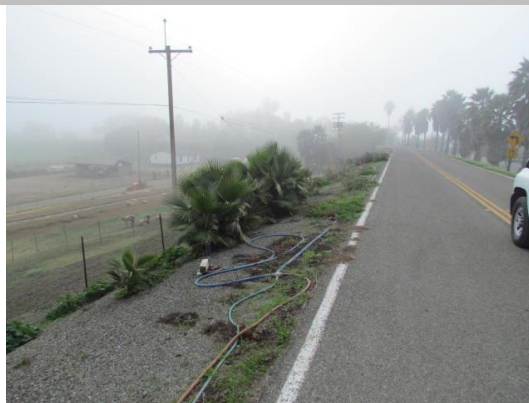
Photo 4 of 4 : SP_2018_RD0999_232_50_20180301_00051.jpg

LM Start	15.33	Rating **	U	Issue No.	50 (cont)	
LM End	15.33	Issue Type +	En	Location *	LS	
Category	Earthen Levee			GPS Latitude/Longitude		
				Start		End
Item	Encroachments			38.291663 °	38.291663 °	
				-121.644962 °	-121.644962 °	
DWR ID	DWR_RD0999_01_f_2012_50					
Comment Code						
TR : Tree or limb						
Inspector Comment						
Planted palm trees on landside shoulder.

Looking east at newly planted palm trees on landside shoulder and slope.

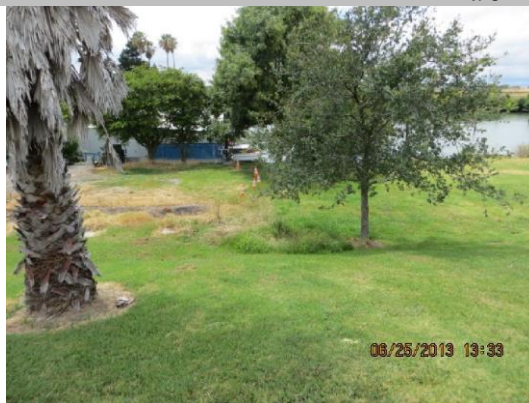
Photo 1 of 3 : UCIP_SP_2018_16330_27512.jpg

LM Start	15.36	Rating **	M	Issue No.	928
LM End	15.36	Issue Type +	En	Location *	
Category	Supplemental			GPS Latitude/Longitude	
				Start	End
Item	DWR UCIP Field Study			38.291192 °	38.291192 °
				-121.644987 °	-121.644987 °
DWR ID					
Comment Code					
Inspector Comment					
FS_ID:16330 DS_ID:23970 EP_NO: N/A Repair Type: Non-Urgent Crossing Status: Found UCIP Comments: No permit identified for this crossing. FIELD_STRUCT_DESC: 4-inch polyvinyl chloride (PVC) water line through the levee, 2 feet below the crown. Pump off the waterside (WS) toe visible at the water's edge. FS Date: 6/25/2013

Pipe visible at WS toe in grass.

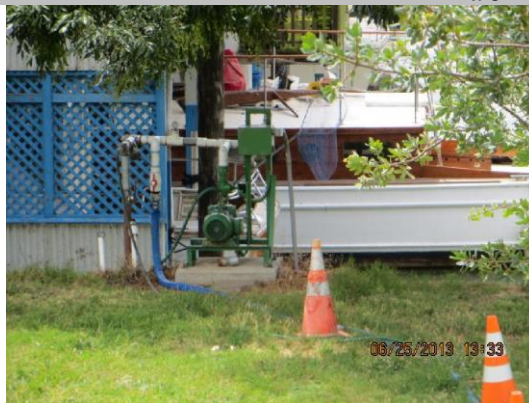
Photo 2 of 3 : UCIP_SP_2018_16330_27511.jpg

LM Start	15.36	Rating **	M	Issue No.	928 (cont)
LM End	15.36	Issue Type +	En	Location *	
Category	Supplemental			GPS Latitude/Longitude	
				Start	End
Item	DWR UCIP Field Study			38.291192 °	38.291192 °
				-121.644987 °	-121.644987 °
DWR ID					
Comment Code					
Inspector Comment					
FS_ID:16330 DS_ID:23970 EP_NO: N/A Repair Type: Non-Urgent Crossing Status: Found UCIP Comments: No permit identified for this crossing. FIELD_STRUCT_DESC: 4-inch polyvinyl chloride (PVC) water line through the levee, 2 feet below the crown. Pump off the waterside (WS) toe visible at the water's edge. FS Date: 6/25/2013

Possible pump visible off WS toe at waters edge.

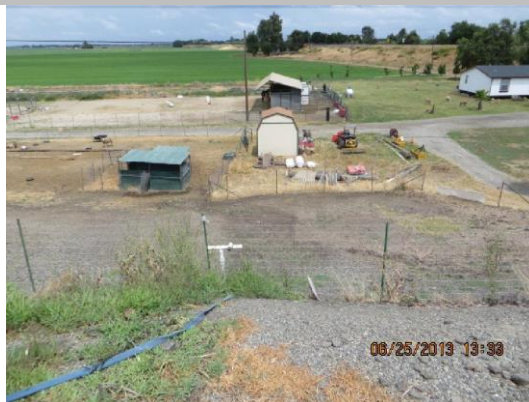
Photo 3 of 3 : UCIP_SP_2018_16330_27510.jpg

Pipe visible on LS toe.

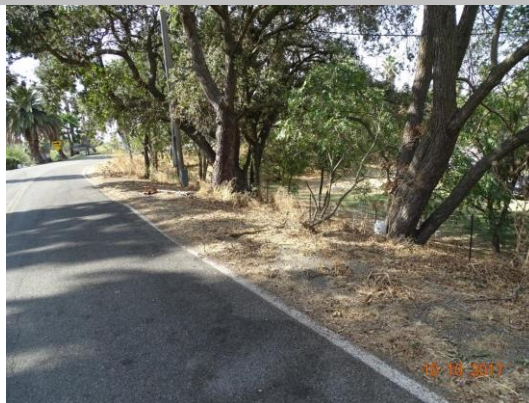
Photo 1 of 3 : SP_2018_RD0999_233_17_20180301_00013.jpg

LM Start	0.01	Rating **	M	Issue No.	17
LM End	0.06	Issue Type +	En	Location *	LS
Category	Earthen Levee			GPS Latitude/Longitude	
				Start	End
Item	Encroachments			38.290355 °	38.290472 °
				-121.644713 °	-121.643888 °
DWR ID	DWR_RD0999_02_s_2012_17				
Comment Code					
FE : Fence					
Inspector Comment					
Landowner has installed fence along landside slope for sheep to maintain levee slope. Landowner should apply for permit to keep fence.

View of landside slope looking northwest.

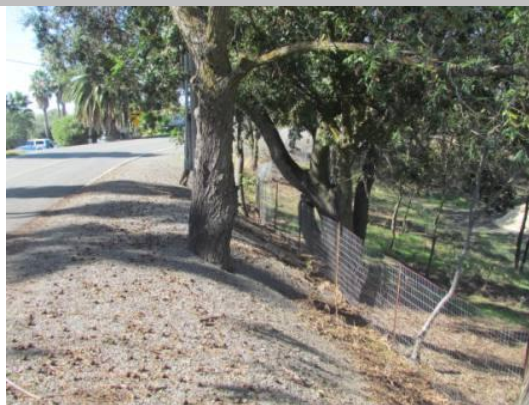
Photo 2 of 3 : SP_2018_RD0999_233_17_20180301_00014.jpg

Looking west at fence along landside slope.

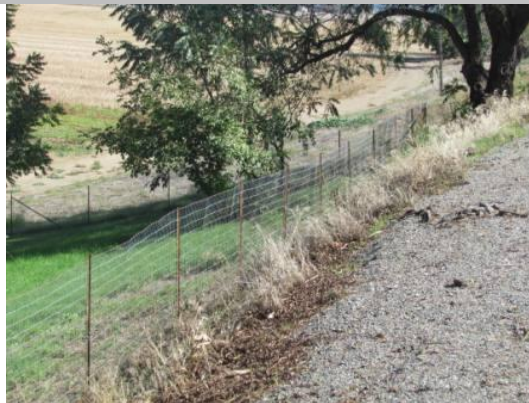
Photo 3 of 3 : SP_2018_RD0999_233_17_20180301_00015.jpg

Looking northeast at fence along landside shoulder.

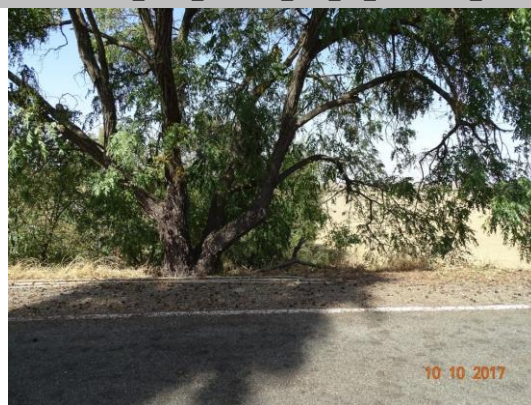
Photo 1 of 1 : SP_2018_RD0999_233_21_20180301_00018.jpg

LM Start	0.06	Rating **	M	Issue No.	21
LM End	0.06	Issue Type +	Ma	Location *	LS
Category	Earthen Levee			GPS Latitude/Longitude	
				Start	End
Item	Trim / Thin Trees			38.290434 °	38.290434 °
				-121.643873 °	-121.643873 °
DWR ID	DWR_RD0999_02_f_2017_21				
Comment Code					
T1 : Trim trees to at least five feet above ground level.					
Inspector Comment

View of landside slope looking north.

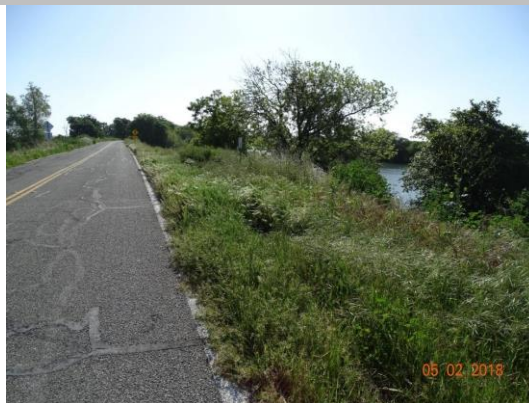
Photo 1 of 1 : SP_2018_RD0999_233_34_20180507_00054.jpg

LM Start	0.08	Rating **	U	Issue No.	34
LM End	0.15	Issue Type +	Ma	Location *	WS
Category	Earthen Levee			GPS Latitude/Longitude	
				Start	End
Item	Vegetation			38.290543 °	38.290753 °
				-121.643501 °	-121.642288 °
DWR ID	DWR_RD0999_02_s_2018_34				
Comment Code					
V1 : Control annual grass and weeds on the levee slopes and easements.					
Inspector Comment

Vegetation waterside looking east.

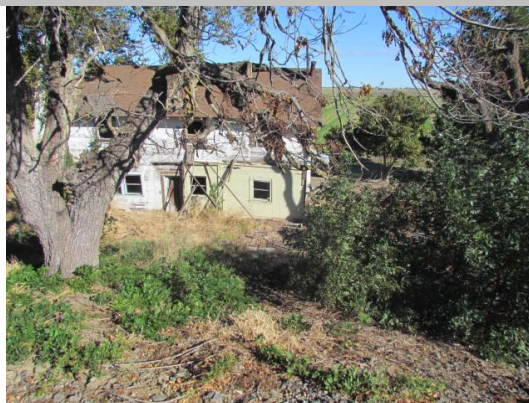
Photo 1 of 2 : SP_2018_RD0999_233_24_20180301_00019.jpg

LM Start	0.18	Rating **	U	Issue No.	24
LM End	0.18	Issue Type +	En	Location *	LS
Category	Earthen Levee			GPS Latitude/Longitude	
				Start	End
Item	Encroachments			38.290871 °	38.290871 °
				-121.641755 °	-121.641755 °
DWR ID	DWR_RD0999_02_f_2013_24				
Comment Code					
BU : Building					
Inspector Comment					
Adandoned building on landward toe and berm.

Looking southwest at abandoned building on landward berm.

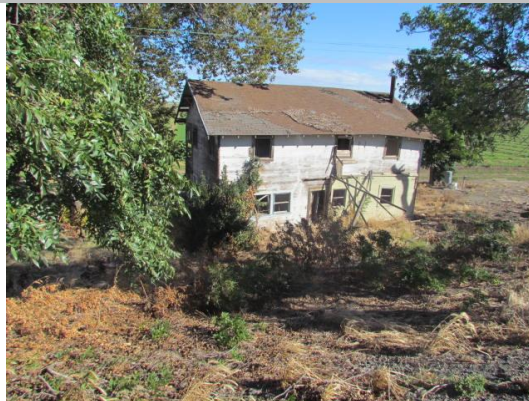
Photo 2 of 2 : SP_2018_RD0999_233_24_20180301_00020.jpg

Looking west at abandoned building on landward berm.

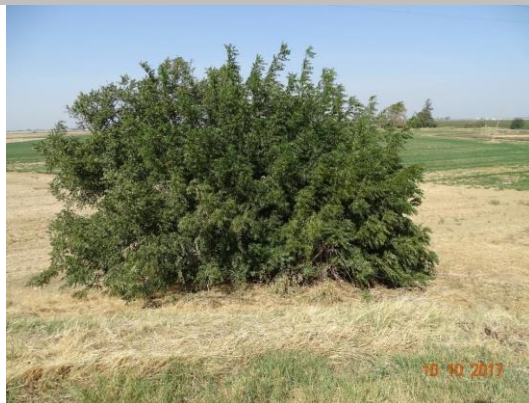
Photo 1 of 3 : SP_2018_RD0999_233_37_20180301_00025.jpg

LM Start	0.73	Rating **	M	Issue No.	37
LM End	0.73	Issue Type +	Ma	Location *	LS
Category	Earthen Levee			GPS Latitude/Longitude	
				Start	End
Item	Trim / Thin Trees			38.292783 °	38.292783 °
				-121.632317 °	-121.632317 °
DWR ID	DWR_RD0999_02_s_2014_37				
Comment Code					
T1 : Trim trees to at least five feet above ground level.					
Inspector Comment

View of landside slope looking north.

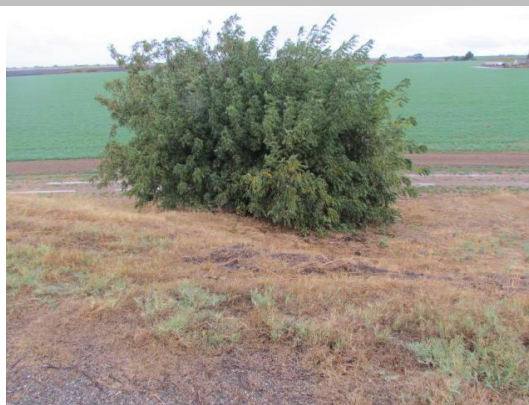
Photo 3 of 3 : SP_2018_RD0999_233_37_20180301_00027.jpg

Looking at untrimmed tree on landward slope. (Spring 2016)

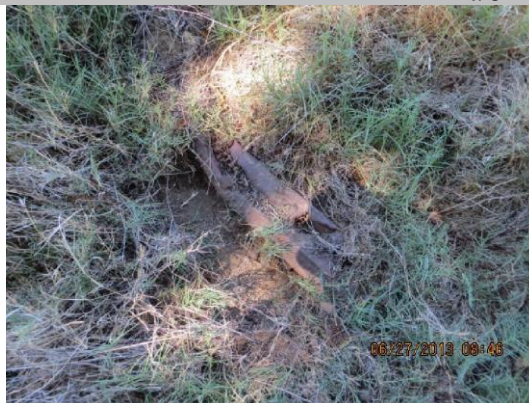
Photo 3 of 3 : UCIP_SP_2018_15384_25240.jpg

LM Start	0.79	Rating **	M	Issue No.	45 (cont)	
LM End	0.79	Issue Type +	En	Location *		
Category	Supplemental			GPS Latitude/Longitude		
				Start	End	
Item	DWR UCIP Field Study			38.292562 °	38.292562 °	
				-121.631331 °	-121.631331 °	
DWR ID						
Comment Code						
Inspector Comment						
FS_ID:15384 DS_ID:22772 EP_NO: N/A Repair Type: Non-Urgent Crossing Status: Found UCIP Comments: Pipe open on both ends. Pumphouse has been removed. Needs to be abandoned properly. FIELD_STRUCT_DESC: *ABANDONED* 8-inch steel irrigation pipe through the levee, 4.5 feet below the crown. Abandoned pump house on the waterside (WS) slope. [Additional Reference(s): DWR Levee Log, 1992. USACE Sacramento O&M Manual 113 (Revised), October 1966, (HLM 0.78)]. FS Date: 6/27/2013

Damaged pipe on LS slope.

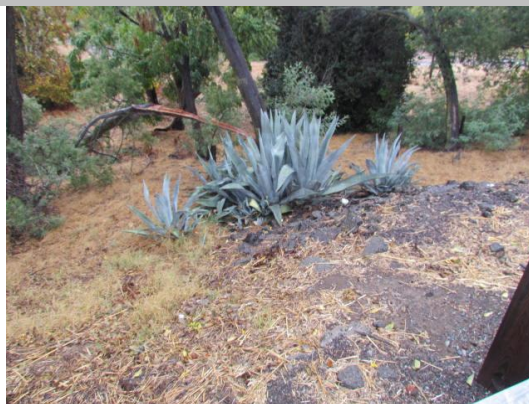
Photo 1 of 2 : SP_2018_RD0999_233_14_20180301_00011.jpg

LM Start	0.82	Rating **	M	Issue No.	14
LM End	0.82	Issue Type +	Ma	Location *	LS
Category	Earthen Levee			GPS Latitude/Longitude	
				Start	End
Item	Vegetation			38.292439 °	38.292439 °
				-121.630781 °	-121.630781 °
DWR ID	DWR_RD0999_02_f_2012_14				
Comment Code					
V2 : Remove the wild growth other than native grasses from the levee slopes.					
Inspector Comment					
Century plant on landside slope.

Looking north at century plant at landward toe fall 2015.

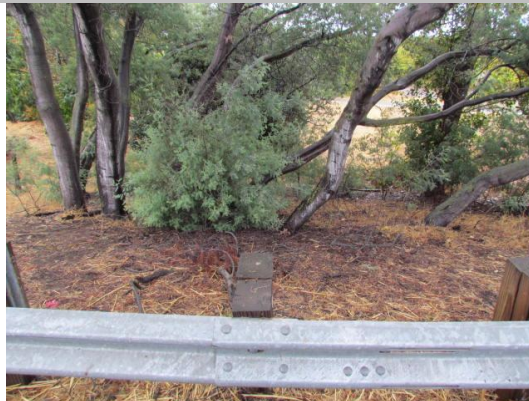
Photo 2 of 2 : SP_2018_RD0999_233_19_20180301_00017.jpg

LM Start	0.83	Rating **	M	Issue No.	19 (cont)
LM End	0.83	Issue Type +	Ma	Location *	LS

Looking north at untrimmed and trees to be thinned at landward toe fall 2015.

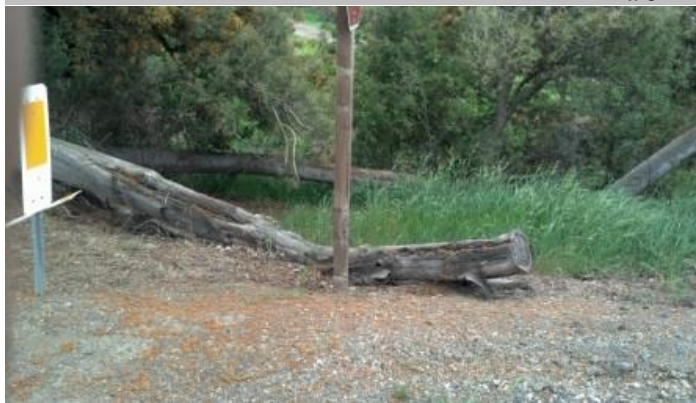
Photo 1 of 1 : SP_2018_RD0999_233_13_20180301_00010.jpg

LM Start	0.84	Rating **	M	Issue No.	13
LM End	0.84	Issue Type +	Ma	Location *	LS
Category	Earthen Levee			GPS Latitude/Longitude	
				Start	End
Item	Encroachments			38.292352 °	38.292352 °
				-121.630452 °	-121.630452 °
DWR ID	DWR_RD0999_02_s_2012_13				
Comment Code					
TR : Tree or limb					
Inspector Comment

Looking northwest at tree limb on landside slope.

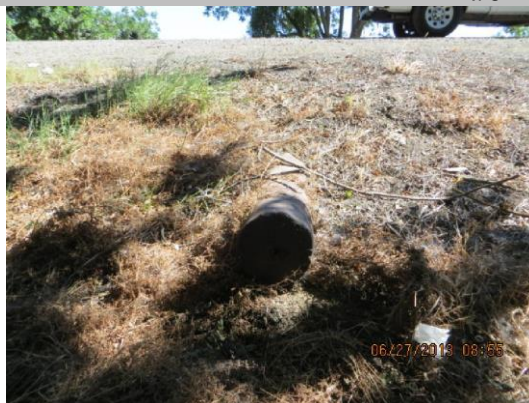
Photo 1 of 3 : UCIP_SP_2018_15385_25246.jpg

LM Start	0.93	Rating **	M	Issue No.	46
LM End	0.93	Issue Type +	En	Location *	
Category	Supplemental			GPS Latitude/Longitude	
				Start	End
Item	DWR UCIP Field Study			38.291739 °	38.291739 °
				-121.628873 °	-121.628873 °
DWR ID					
Comment Code					
Inspector Comment					
FS_ID:15385 DS_ID:22773 EP_NO: N/A Repair Type: Non-Urgent Crossing Status: Found UCIP Comments: Pipe should be abandoned properly. FIELD_STRUCT_DESC: *ABANDONED* 10-inch steel irrigation pipe through the levee, 4.9 feet below the crown. Capped on both ends. [Additional Reference(s): DWR Levee Log, 1992. USACE Sacramento O&M Manual 113 (Revised), October 1966, (HLM 0.93)]. FS Date: 6/27/2013

Pipe with welded steel plate over end visible on WS

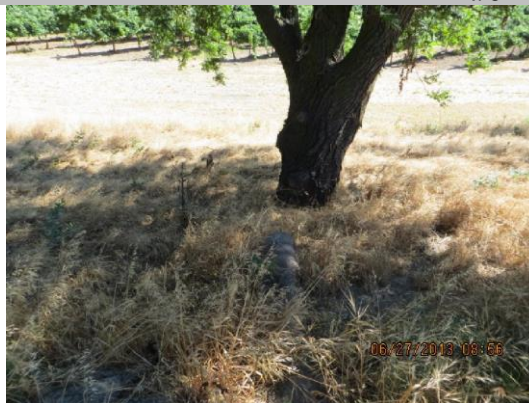
Photo 2 of 3 : UCIP_SP_2018_15385_25245.jpg

LM Start	0.93	Rating **	M	Issue No.	46 (cont)
LM End	0.93	Issue Type +	En	Location *

Pipe with welded steel plate over end visible on LS

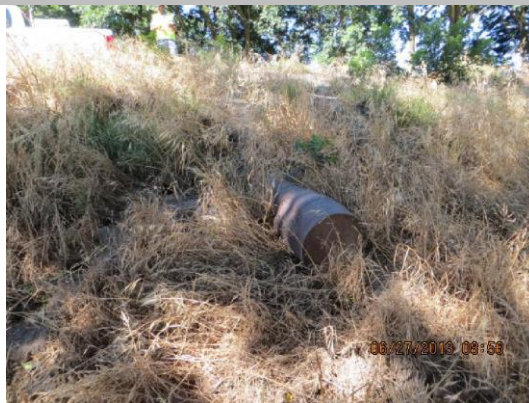
Photo 3 of 3 : UCIP_SP_2018_15385_25244.jpg

Pipe with welded steel plate over end
